*State of Illinois*  
**ENVIRONMENTAL PROTECTION AGENCY**  
**MEMORANDUM**

**DATE:** September 29, 2010  
**TO:** Division Files - Bureau of Land  
**FROM:** Chris Cahnovsky – Collinsville Region  
**SUBJECT:** 1198010003 – Madison County  
Estate of Chemetco  
FOS File

On September 15, 2010, Michelle Cozadd and I conducted an inspection at Chemetco, Inc. Present during this inspection were Jorge Garcia, ES&H Manager for the Estate of Chemetco and Mike Murray of AIS.

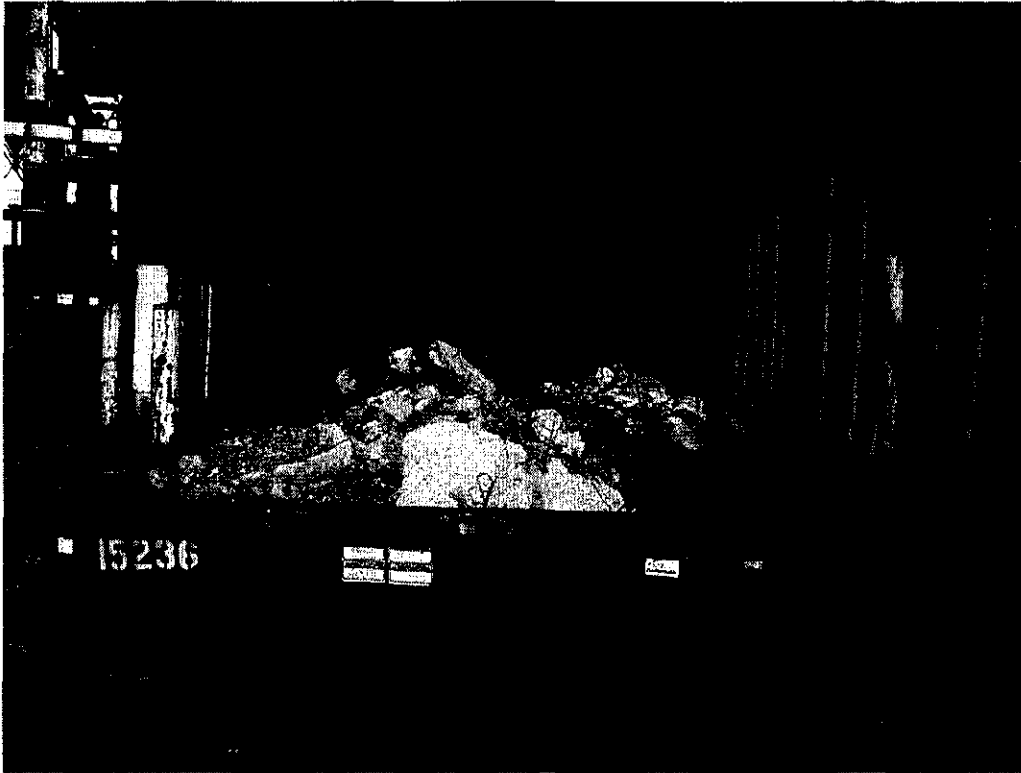
Date: 09/15/2010  
Time: 9:00 – 10:30  
Direction: Northwest  
Photo by: Chris  
Cahnovsky  
Exposure #: 001  
Comments: Roll-off box  
of concrete loaded  
for Roxana Landfill.  
Box is over weights  
and needs to be  
reloaded.

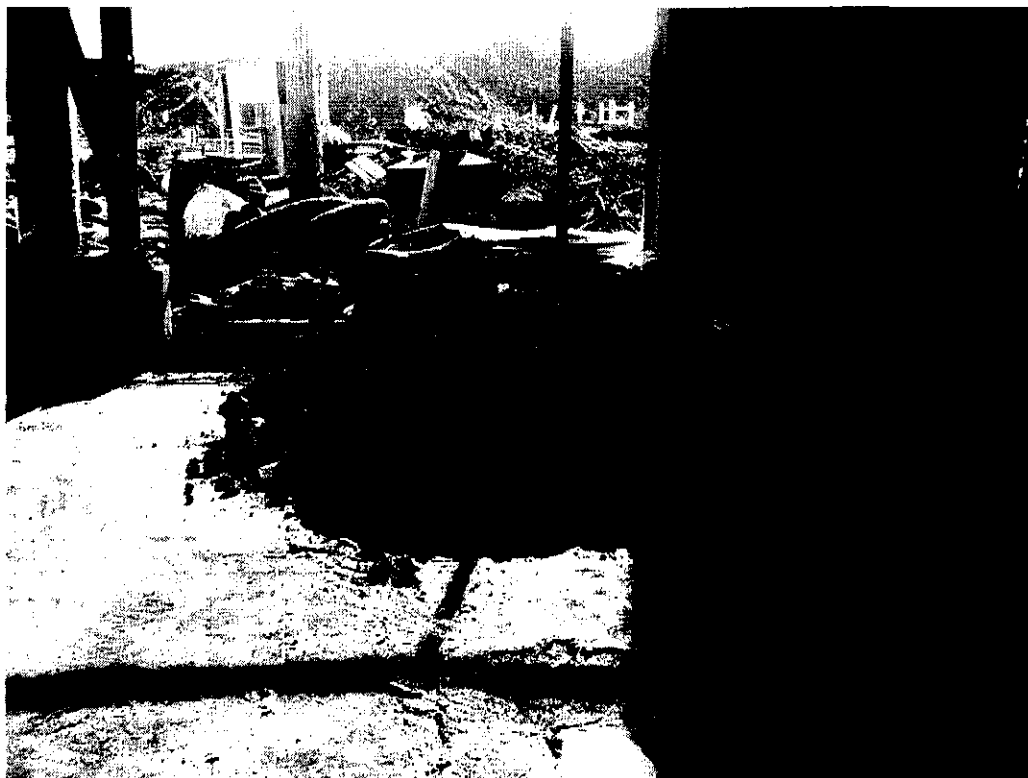
Date: 09/15/2010  
Time: 9:00 – 10:30  
Direction: West  
Photo by: Chris  
Cahnovsky  
Exposure #: 005  
Comments: MBM pile  
remaining after  
clean up of the Fine  
Building Hallway

Mr. Jorge showed us the area of the Tank House referred to as the Hallway. The Hallway is an area on the north side of the Tank House that extends the length of the building. This area has been cleaned out and the remaining fines have been accumulated at the east end of the Hallway. These fines are being taken over to the Fines Building.

I also observed a pile of fines from the Hallway area of the Tank House. This pile contained trash such as a filter press frame, wood, pipe and other waste. I explained that this type of material is a waste and not MBM. I explained to Mr. Garcia that no more MDM or waste can be brought to the Fines Building until the waste material was removed. Mr. Garcia provided copies of the weekly inspection of the Fines Building to the Agency for review.

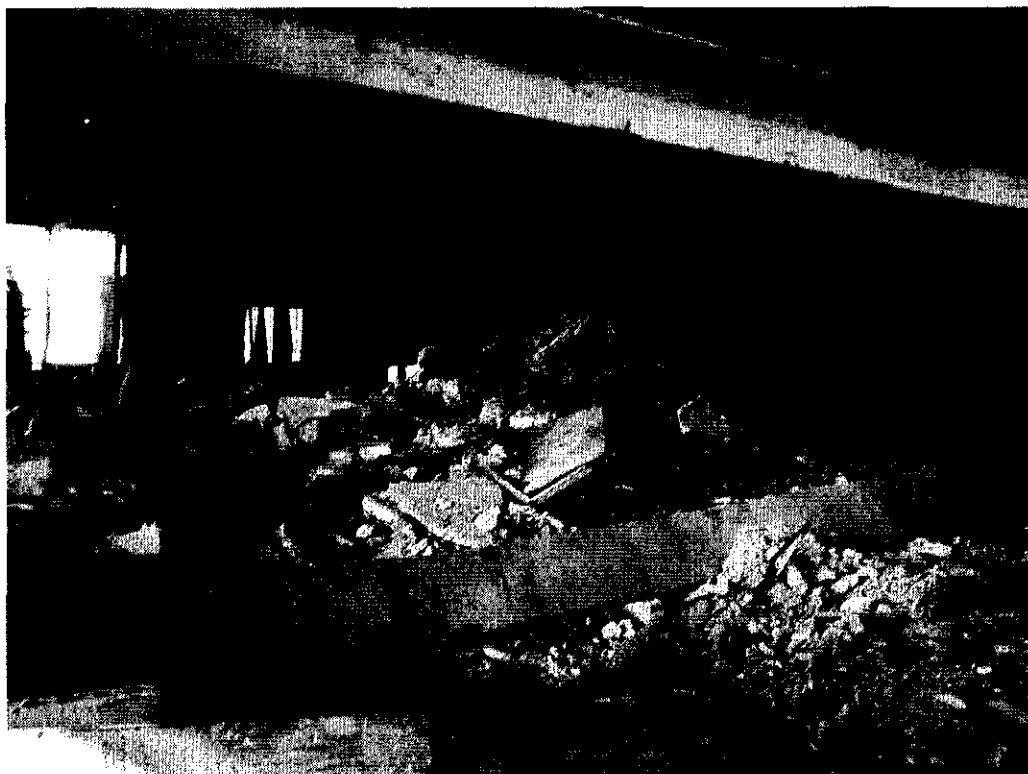
Date: 09/15/2010  
Time: 9:00 – 10:30  
Direction: Southwest  
Photo by: Chris  
Cahnovsky  
Exposure #: 006  
Comments: Remaining  
concrete from cell  
demolition in Tank  
House

The Tank House still contains a significant amount of concrete. I explained to Mr. Garcia and Mr. Murray that I was concerned that concrete mixed with fines (metal bearing materials or MBM) were going to be taken to the Fines Building. I pointed to several areas within the work zone that I had concerns with. Mr. Murray stated that he intended to send concrete that was mixed with the fines to the Fines Building. He stated that the concrete would be crushed and treated by Paradigm. I explained that I did not think that the concrete had recoverable amount of metals in it to be considered MBM.

2. The IEPA and USEPA are taking the position that all the concrete from the Tank House is a waste. According to the approved demolition plan the concrete pits will be broken on the floor of the Tank House and the concrete debris will be put into a temporary working pile inside the building and then transferred into containers or trucks for off-site disposal. The concrete must be managed as a waste. It appears that the majority of the concrete is a non-hazardous special and has already been profiled into Roxana Landfill. The smaller rubble/cobble/crums will need to be separated from the other floor debris and sampled for hazardous waste characteristics. All practical measures must be taken to keep this concrete out of the Fines Building and make correct waste determinations.

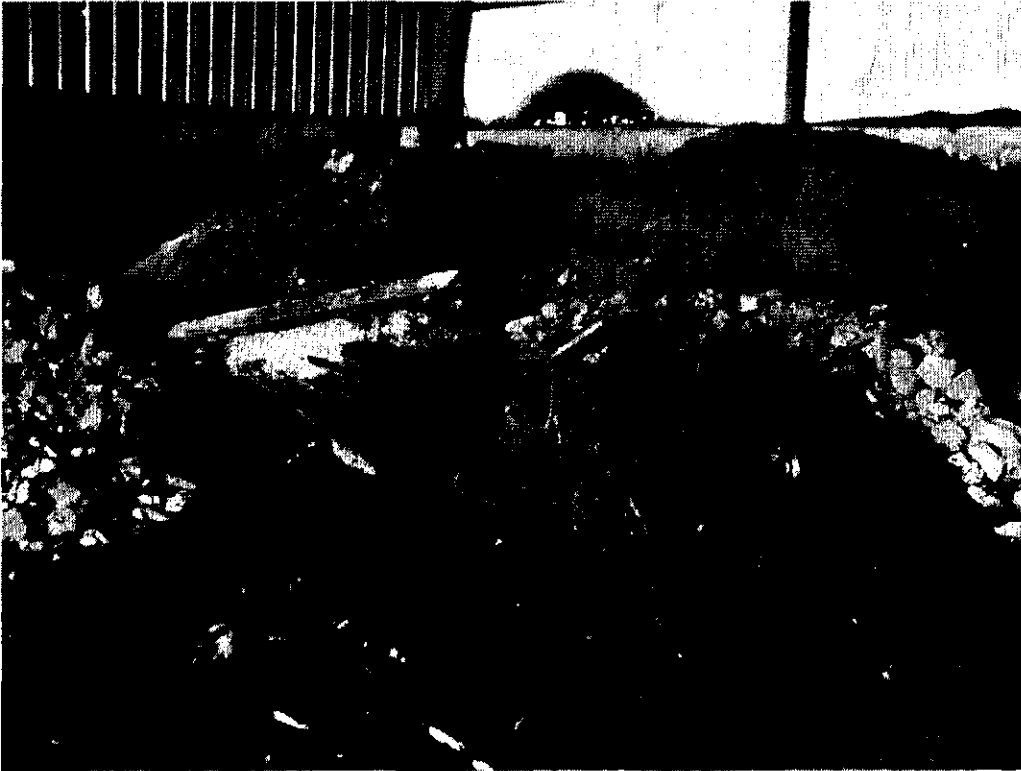
Date: 09/15/2010  
Time: 9:00 – 10:30  
Direction: Northwest  
Photo by: Chris  
Cahnovsky  
Exposure #: 009  
Comments: Trash in  
Fines Building

1. In the Fines Building the IEPA observed a pile of floor sweeping. In this pile was a filter plate, metal pipe, wood and other trash. Also concrete with rebar and fiberglass decking waste were observed in the building. This type material must be kept out of the Fines Building and managed as a waste. No more material may be placed into the Fines Building until this waste has been removed. Jorge Garcia has called me let me know that the material has been removed and he will forward pictures to the Agency.

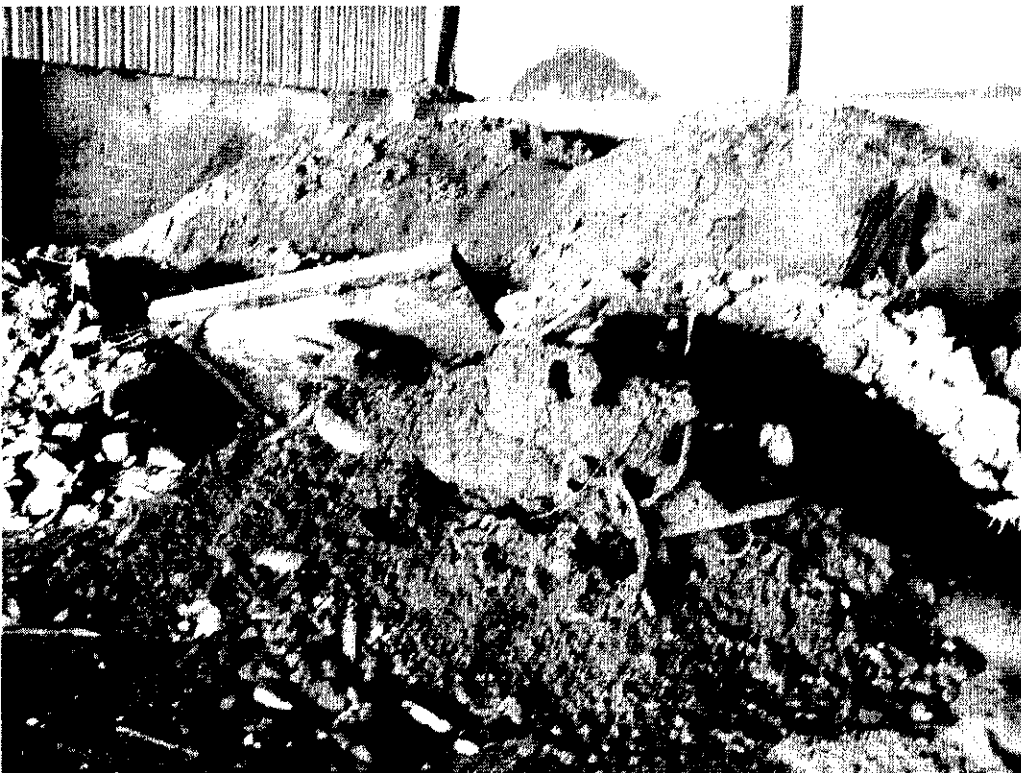
Date: 09/15/2010  
Time: 9:00 – 10:30  
Direction: Northwest  
Photo by: Chris  
Cahnovsky  
Exposure #: 010  
Comments: Trash in  
Fines Building

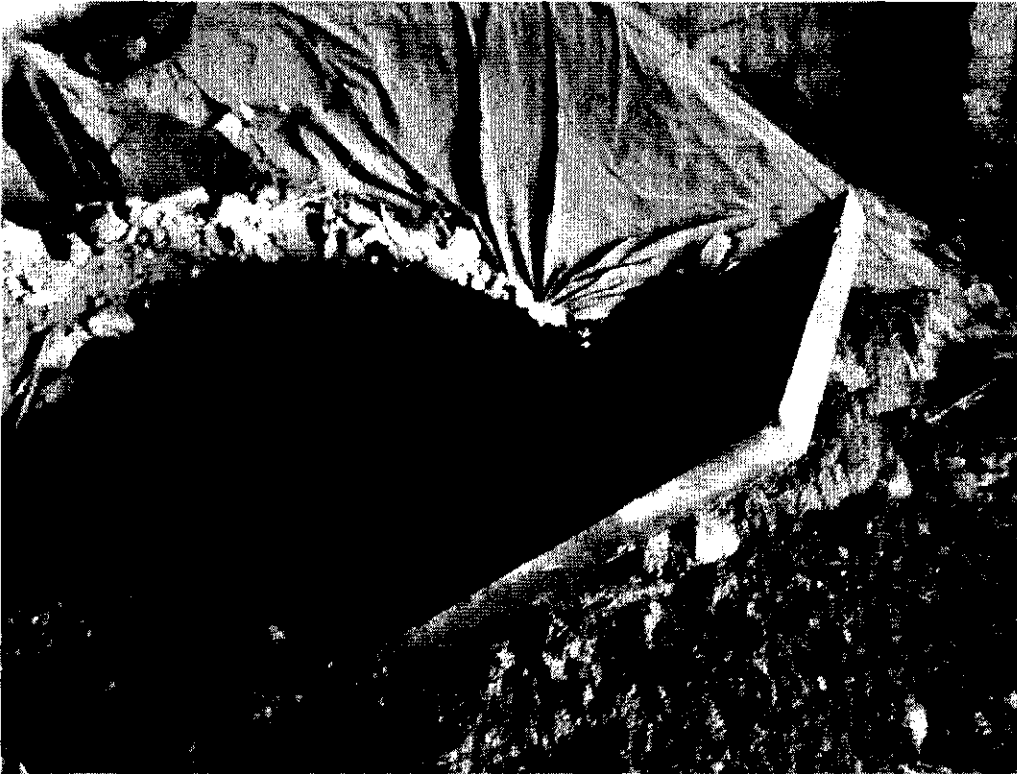
Date: 09/15/2010  
Time: 9:00 – 10:30  
Direction: North  
Photo by: Chris  
Cahnovsky  
Exposure #: 013  
Comments: Concrete  
with trash

I then inspected the Fine Building. In this building I observed about four loads of concrete mixed with scrubber sludge. These piles contained large pieces of concrete with protruding rebar. I observed other trash mixed in with the concrete. It appears that this material meets the definition of general construction or demolition debris and not metal bearing material that Paradigm can use in their process. I explained to Mr. Garcia that no more concrete could be placed in this building.
